Landslide Disaster at Mt. Bawakaraeng Caldera, South Sulawesi, Indonesia ^{*1}Hasnawir ^{*2} · H. Omura ^{*3} · T. Kubota ^{*3}

Hasnawir · H. Omura · T. Kubota : **Landslide Disaster at Mt. Bawakaraeng Caldera, South Sulawesi, Indonesia** 九州森林研究 59 : 269—272, 2006

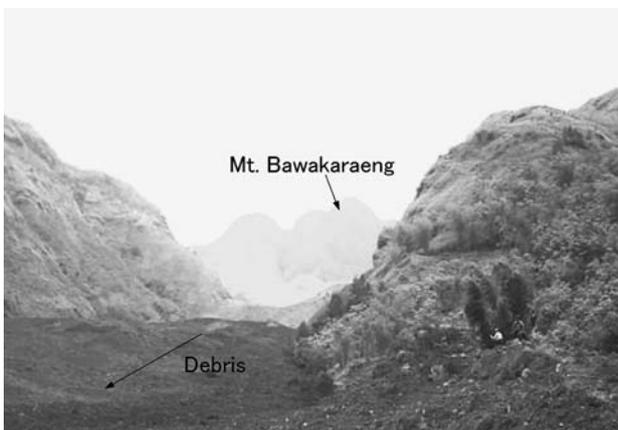
An enormous amount of earth and debris ran down the slope and accumulated as much as 7 km along the valley (Fig - 2). Two collapsed areas are found at the source section of the landslide: one occurred near Mt. Bawakaraeng is a collapse with a width of 500 m (Collapse A); the other is a large collapse at the ridge of Mt. Sarongan, which occurred in a horseshoe shape with a horizontal length of about 1,300 m (Collapse B). The relative height of the failure slope in both collapses is about 700 m (Fig - 3).

Fig - 2. The landslide-debris at Mt. Bawakaraeng

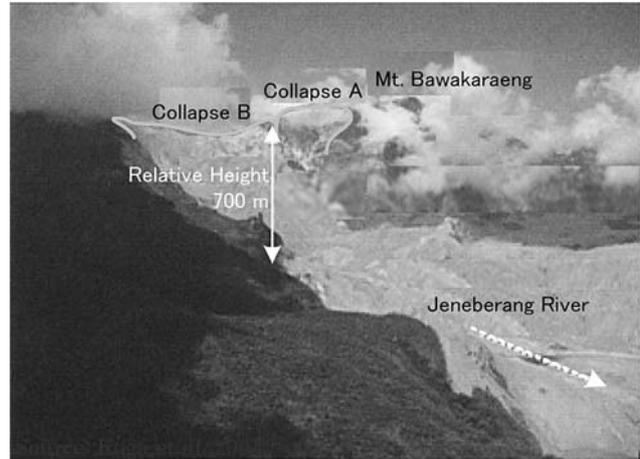
Fig - 3. Sites of collapse areas

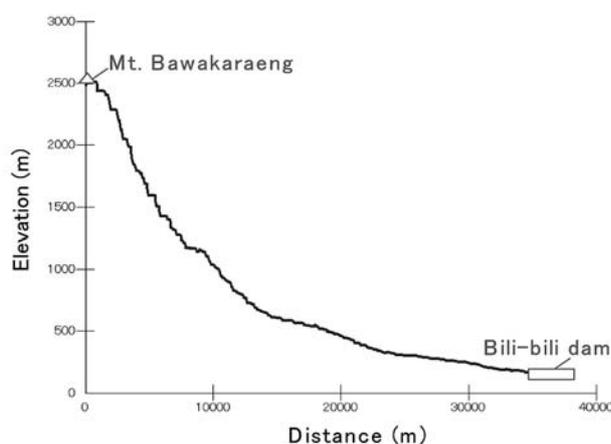
Fig - 4. Cross section of Jeneberang River

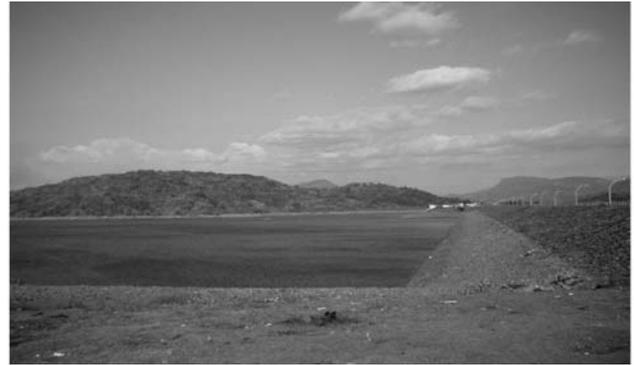
Fig - 5. The river water before the landslide (clear water)

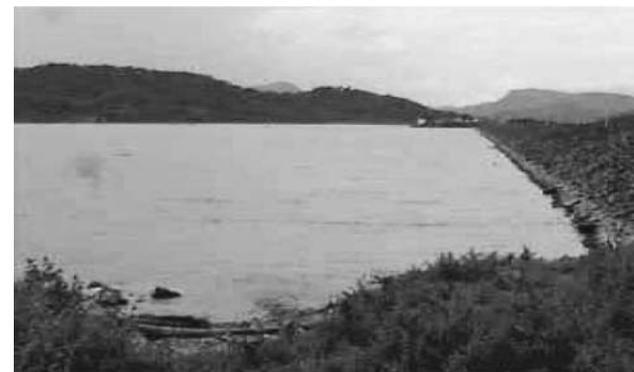
Fig - 6. The river water after the landslide (muddy water)
